PLAN TO ILLUSTRATE DR BLISS'S TWELFTH REPORT

PALESTINE EXPLORATION FUND

## TWELFTH REPORT ON THE EXCAVATIONS AT JERUSALEM.

By F. J. BLISS, Ph.D.

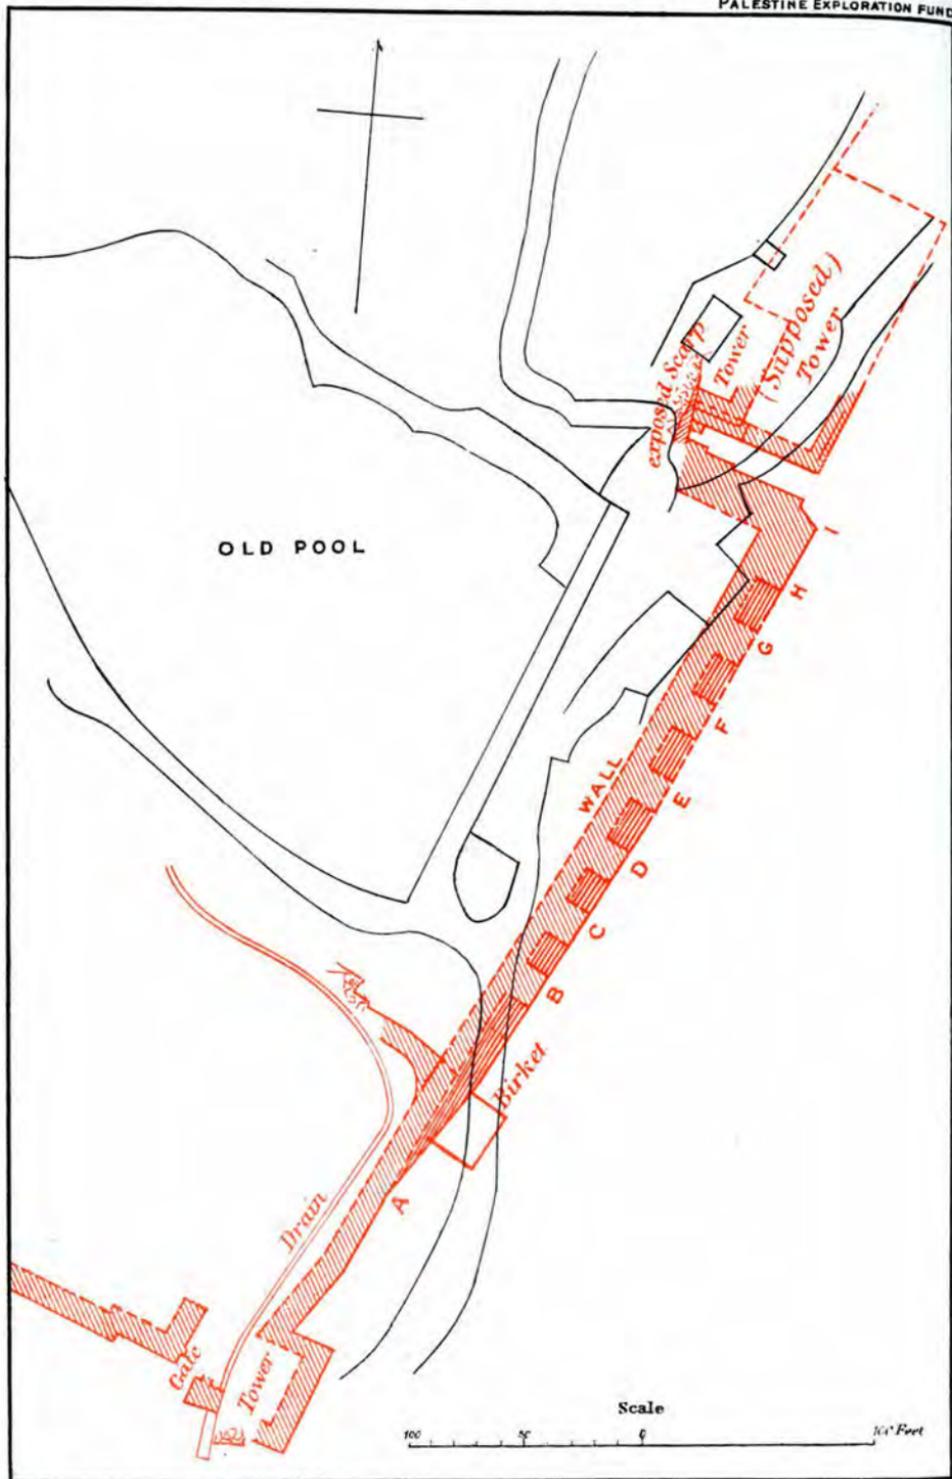
I must now refer the reader to the plan accompanying the Sixth Report, published in October, 1895, on which is shown the wall from the second gate to the point where it was traced crossing the mouth of the Tyropœon below the Old Pool. From the point B on, the wall shows signs of two distinct periods. The earliest is the line BK, from which at E, F, and I there advance buttresses, resting on a base-wall projecting in a line with their faces. The later period is represented by the line BJ, and was explained as follows:—"The first wall fell into ruins beyond the point B, but the buttresses and the base-wall remained. When the wall came to be repaired advantage was taken of these solid remains, the base-wall between the buttresses was carried up to the top, completing an unbroken face of wall, and this new line, at I, 12 feet outside the old line, was carried back to B, with a gradually diminishing distance between the two lines, till they met at B" (p. 311). A third period was indicated by a rough retaining wall of pocked stones (not figured on the plan, but shown in the sections), which was rendered necessary by the dangerous forward bulging of the wall owing to pressure of water from the Pool. On the present plan, the point of divergence B is represented by the letter A, and the first two periods are distinguished from each other by a difference in hatching.

The identity of the wall described at this corner with that excavated in 1895 is further proved by a detailed examination. In both cases the base-wall has a batter. The masonry of the buttresses is also the same: a mixture of drafted and plain-faced stones. The bosses project from  $1\frac{1}{2}$  to 6 inches, the margins are worked by chisel-draft, but in a very few cases on the stones of the last discovered buttress the comb-pick has been used. In both cases the absence of lime was noted. In describing the buttresses discovered in 1895 I remarked that it was impossible to tell the character of the setting, as the joints were wrenched apart by pressure, causing the whole face to bulge forward.<sup>1</sup> The corner buttress HI preserves a perpendicular face, and a fine jointing is observed in the setting of the stones. As the wall here does not bulge forward there was no need of carrying the rough outer retaining wall to this point; at any rate, no such wall was found here. However, in front of HI there was masonry so ruined that we could make nothing of it, but as it was not bonded into the main wall it is clearly some later addition. As the wall at HI is proved to be identical with the wall discovered before, we have dotted in the part not excavated, assuming the buttresses E, F, and G.

The corner buttress HI is interesting. A few feet to the right of the shaft (*see* elevation HI) the last two stones of the top course drop, and appear to be set on end, being shifted from their original position. Beyond these only roughly-squared, quarry-picked stones carry on the line to the corner I, where bossed stones would be expected, if anywhere. Turning the corner, we tunnelled along the line IJ at an obtuse angle with IH (*see* key plan) to the point J, where a projection of 18 inches occurs. To the left of the projection (*see* elevation IM) the two top courses are of well-squared picked stones. Work had here become

such beds may be seen on elevation NP. This is a most important point, as it proves that the wall was carried fairly up the eastern hill. The presumption is strong that it ran on to meet Warren's Ophel Wall.

We have now to consider the wall TR (*see* key plan). This advances at about right angles from the wall NP, which, however, runs *back* of TR, sure proof that the latter is an addition. The face of TR consists of masonry similar to that found at K, but the height of the courses is greater, averaging 13 inches instead of 10½. The stones are well set in lime, having picked centres and comb-picked margins, but no projections. Towards T the dressing becomes finer, and a fine, comb-pick dressing mingles with the picked-work in the centres. About half-way between T and R a straight joint runs through the thickness, not occurring, however, in the facing stones. To the left of this joint the thickness is 8 feet; beyond the joint it is 9 feet. At the point R this wall no longer rests on the rock but on the consolidated stuff mentioned before. At R the wall stops, but we have no clear corner. Trenching in a line further on failed to reveal any continuation of TR. However, the rude wall RS was followed for some 35 feet at right angles. Breaking through its face at two places we found its thickness to be only 3 feet, but it was built up against a face of a *second* wall, which turned out to be 5 feet thick. This second face is of masonry, in general similar to that at TR, but not so finely dressed or well-set. Beyond S much work was done, which was tedious and expensive, owing to complicated land-ownership, and to the fact that we were obliged to destroy numerous small plots of lettuce at one shilling and ninepence the plat. Hence it was a disappointment to find no further traces of RS, though the point where it stopped was not ascertained within a few feet, owing to a quarrel between two landowners as to their boundary.

Our theory as to the line TRS is as follows:—The thickness of the wall TR makes it probable that it was part of the city wall, and its position indicates that it may have formed the side of a tower; the absence of a good corner suggests that this tower may have projected further; the *inner wall* along the line RS (5 feet thick) may have been a partition wall within the tower; when the original outer face was ruined the projection of the tower was decreased and the inner partition was strengthened by the added face, 3 feet thick, thus forming a new outer face, 8 feet thick, for the curtailed tower. The straight joint within the thickness of TR suggests some other sub-period. The probable limits of this tower are indicated by dotted lines on the general plan.

1. The wall with advancing buttresses, built without lime. This wall is in general 8 feet thick, but rests on a base-wall projecting in a line with the buttress faces, which project 11 feet from the upper wall, giving 19 feet as the thickness of the base-wall. A large corner buttress occurs at HI, the line running back north-west to the point N, and then turning up the hill in a north-easterly direction. Between the corner I and the point N this first wall had been much damaged, but the original

masonry is *in situ* at J. This system is represented on the key-plan in solid black.

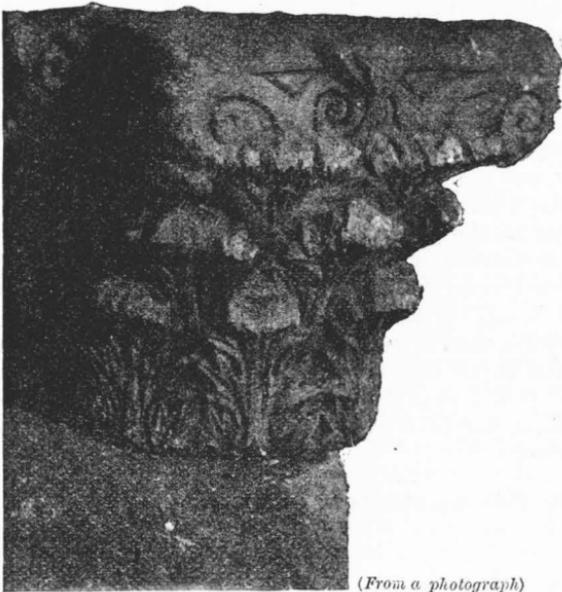
CAPITAL FROM THE BYZANTINE CHURCH FOUND IN THE EXCAVATIONS  
AT THE POOL OF SILOAM.
